CALIFORNIA DIVISION OF MINES AND GEOLOGY

FAULT EVALUATION REPORT FER-94

October 19, 1979

Calaveras (Hollister segment), and "Buena Vista Road" faults.

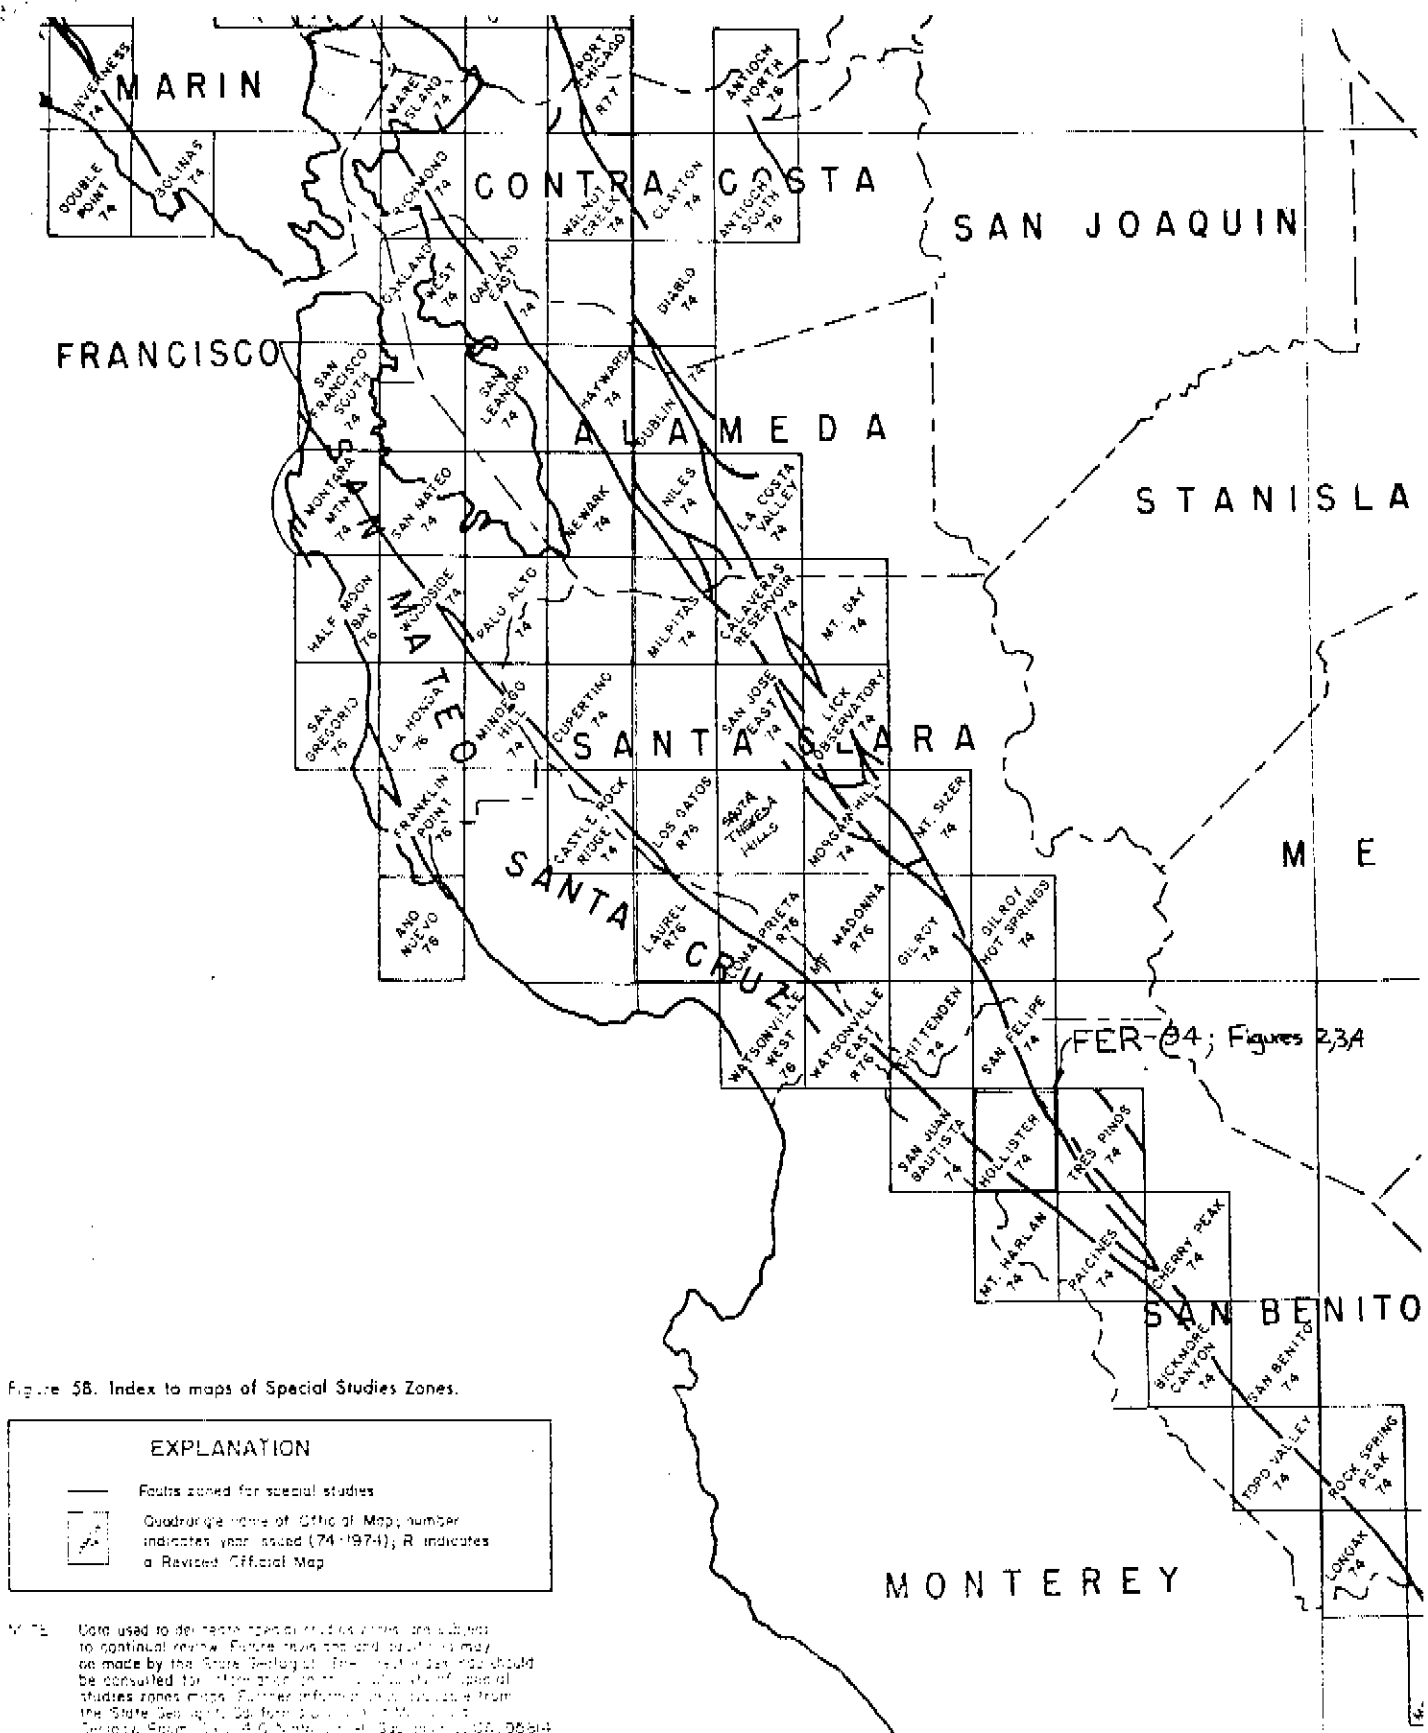
Figure 1 (to FER-94). Index to main faults and Special Studies Zones, CDMG Hollister quadrangle (from Special Publication 42, p.13).

Hollister 7.5 - minute quadrangle, San Benito County (figure 1).

The Special Studies Zones (SSZ) of 1974 depicted on the Hollister 7.5 - minute quadrangle (figures 1 and 2) were based on fault traces mapped by Nason (1971), Radbruch (1968), Rogers (1973), and Taliaferro (1948). Faults shown on the SSZ Map and to be discussed in this fault evaluation report (FER) include the Calaveras fault zone, San Andreas fault zone, and a north-east trending fault informally referred to in this report as the "Buena Vista Road" fault.
